# Restoration and highlight of Agioi Theodoroi church in Nafplio with the use of CAD technologies

**Abstract.** The church of Agioi Theodoroi is located north of the new city of Nafplion in Greece. It is not proclaimed monument, but it constitutes important historical evidence of recent history of the city and of Greece in general, given that it is documented to be associated with one of the protagonists of the Revolution of 1821 Theodoros Kolokotronis and therefore it is inextricably linked to the collective historical memory.

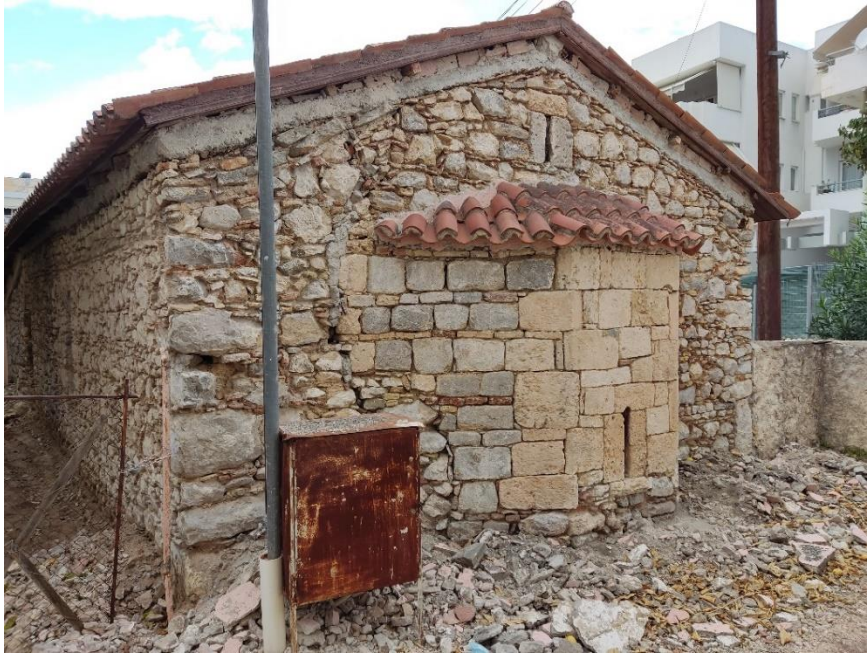
**Fig. 3.** South–East view of the church. Removal of plaster on the exterior masonry. (24/9/2022)

To date, the removal of plaster on the exterior masonry, the test cuts on the interior masonry, the excavation of the northern part of the surrounding area, the removal of interior floors and the detachment of the newest part of the iconostasis have been carried out (see Fig.2, Fig.3, Fig.4, Fig.5)
