Restoration and highlight of Agioi Theodoroi church in Nafplio with the use of CAD technologies

Dimitris Psychogyios, Katerina Leptidou

Keywords: Cultural Heritage, CAD, Thematic maps, local communities, multi-disciplinary approach.

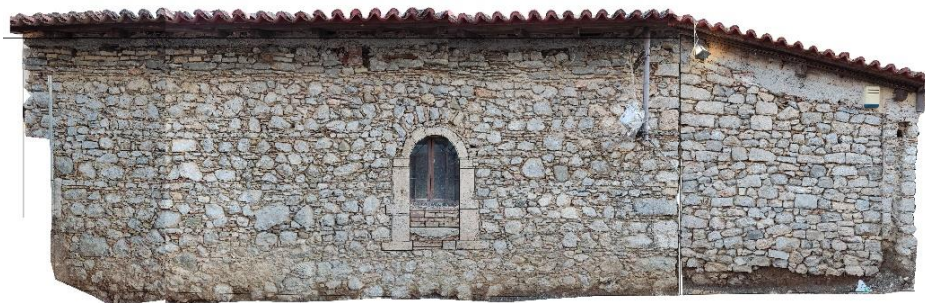
Fig. 11. Orthoimage of the north façade.

The next step was to process the sketches and photographs of each facade and convert them into drawings using CAD technologies. Initially, each façade was worked out as a different project using masks of edited images. After processing the data for all facades, a 3D model of the Catholic Church was constructed. Selected images were used to process the orthoimages of each facade to ensure quality texture. To advance the interdisciplinary process, four orthoimages were created, one for each facade of the church. These orthoimages served as blueprints for further processing of thematic maps incorporating not only qualitative information but also quantitative data. (See Fig.11, Fig.12)

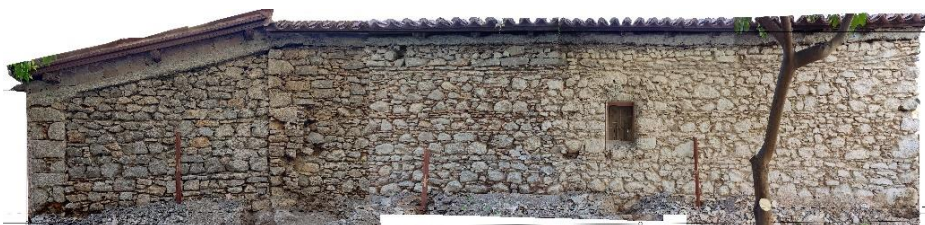
Fig. 12. Orthoimage of the south façade.
