Restoration and highlight of Agioi Theodoroi church in Nafplio with the use of CAD technologies

Dimitris Psychogyios, Katerina Leptidou

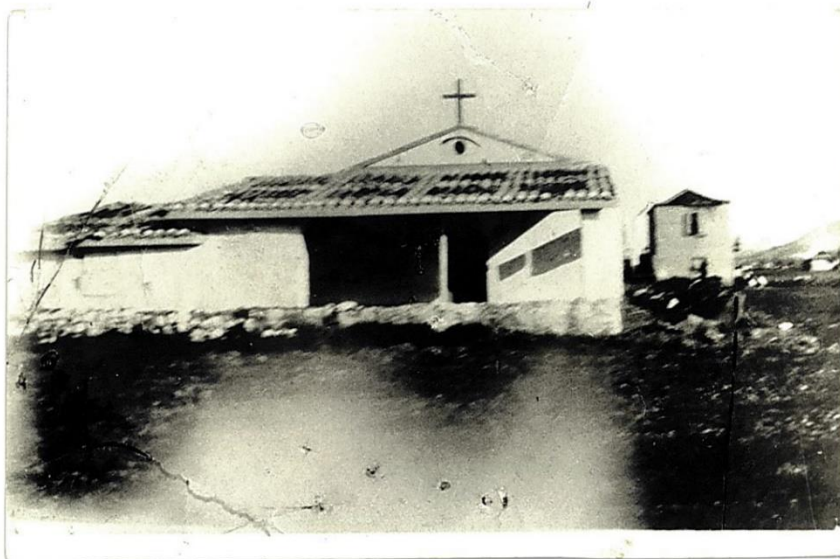
Fig.8. Photographic documentation of the west façade (adopted from [14]).

As mentioned above, a preliminary survey was carried out to collect all available information on the architectural analysis of the monument since there was no previous documentation for this particular building. Also, a scientific conference [26] was organized with invited speakers from different scientific fields (history, archaeology, architecture, law) directly or indirectly related to the temple. In addition, in the context of the conference, an open invitation was made to institutions and citizens of the local community to contribute evidence related to the temple. Finally, a survey was carried out on previous interventions in the temple. All interrelated information regarding the documentation and investigation of the current state of preservation of the temple consists of various elements. Beginning with the historical documentation, a complete and in-depth understanding of the structure and history was achieved through a thorough literature search, including past photographs, drawings and plans of the historical documentation (see Fig.8, Fig.9, Fig.10).

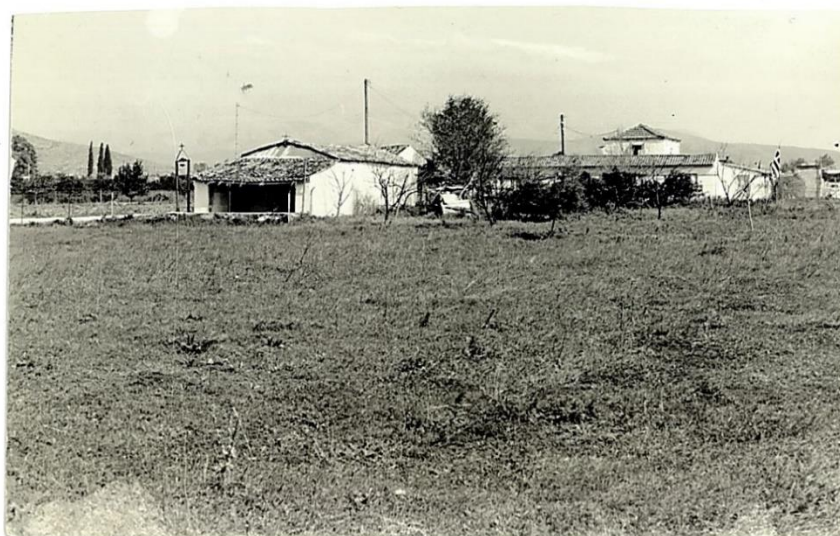
Fig. 9. Photographic documentation of south-west view (Adopted from [14]).

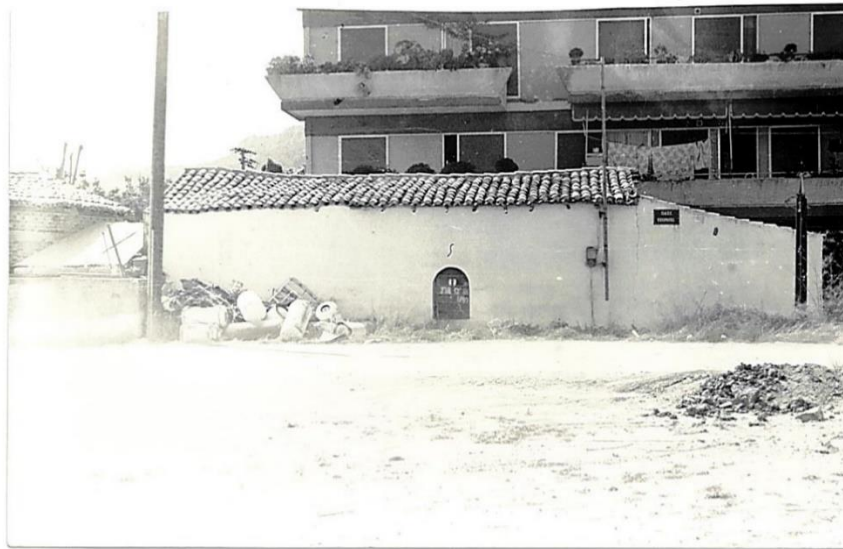
Fig.10. Photographic documentation of north facade (Adopted from [14]).

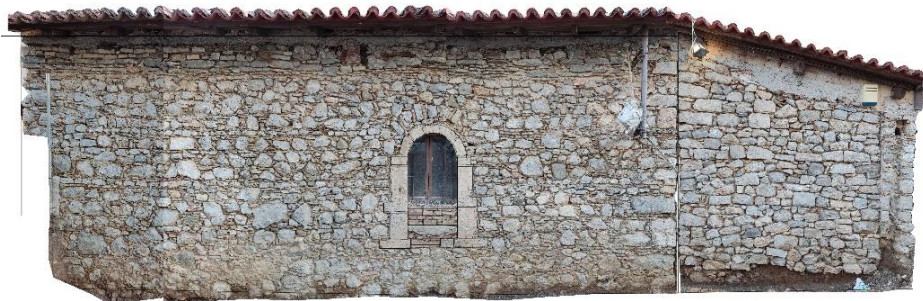
Fig. 11. Orthoimage of the north façade.

The next step was to process the sketches and photographs of each facade and convert them into drawings using CAD technologies. Initially, each façade was worked out as a different project using masks of edited images. After processing the data for all facades, a 3D model of the Catholic Church was constructed. Selected images were used to process the orthoimages of each facade to ensure quality texture. To advance the interdisciplinary process, four orthoimages were created, one for each facade of the church. These orthoimages served as blueprints for further processing of thematic maps incorporating not only qualitative information but also quantitative data. (See Fig.11, Fig.12)

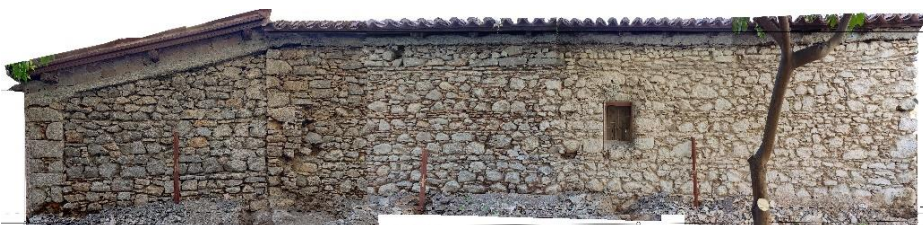
Fig. 12. Orthoimage of the south façade.
