**Digital documentation of three largest subterranean structures of Hagia Sophia: The passage under the esonarthex, the vaults under the atrium and the hypogeum**

*Hasan Firat Diker*

**Abstract.** The terrestrial scanning project of Hagia Sophia's subterranean structures took place in 2020. This field study enabled the creation of a three-dimensional point cloud model capturing the underground tunnels and structures. Subsequently, in 2022, a more detailed documentation of the older hypogeum within Hagia Sophia was conducted. This study particularly focused on the three largest subterranean structures on the site. The first of these is the passage beneath the esonarthex, delineating a structural transition between the Theodosian and Justinian periods, spanning from the fifth to the sixth centuries. Notably, the discovery of a previously unnoticed column base on the floor of this structure prompted an update to the plan of the Theodosian atrium. The second focus lies on the vaults beneath Justinian's atrium, requiring an architectural visualization update since Schneider's documentation in 1941. These subterranean structures define the boundaries of the no longer physically existin

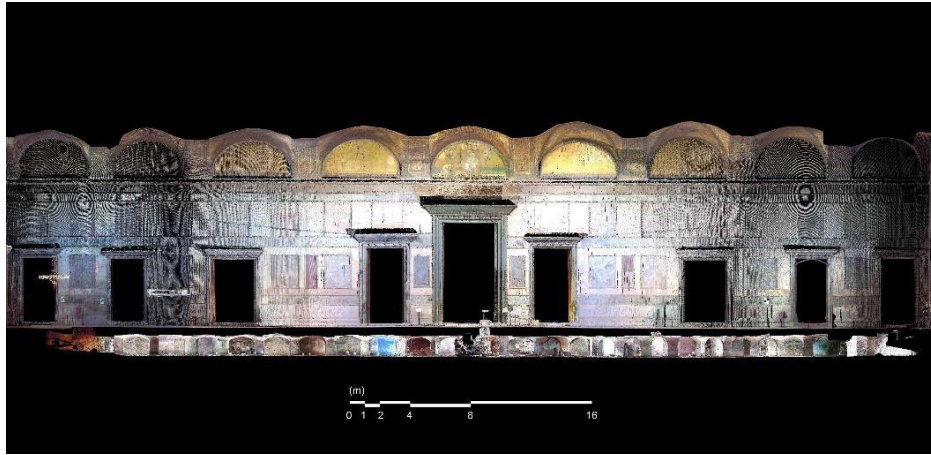
**Fig. 4.** Section 1-1: Northeast-southwest cross-section of the passage under the esonarthex.

Accessible through an opening west of the Imperial Gate (see Figs. 1, 4), the passage beneath the esonarthex resides approximately 2 meters below the ground floor. Measuring 4 meters in width and spanning 47.50 meters in length, this space runs along a northeastern-southwestern axis beneath the southeastern half of the esonarthex. Its ceiling consists of cross vaults connected in the middle with the 23 masonry piers aligned in row. Notably, three channels extend from each end of this passage, diverging in various directions. Serving as a central nexus, this passage interconnects with the subterranean tunnels extending both within and outside the Hagia Sophia structure. On the other hand, in comparison to the following two subterranean structures, this passage is in good condition structurally and free of debris.

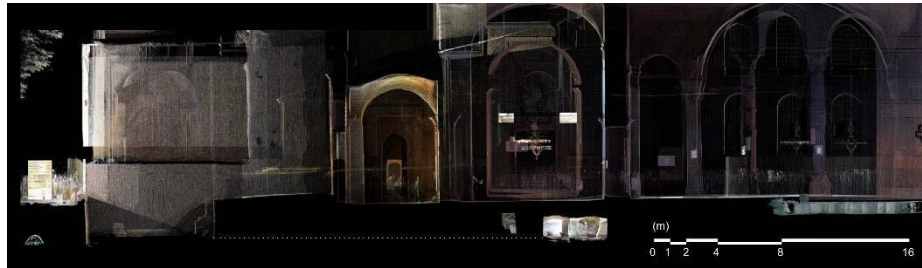
**Fig. 5.** Section 2-2: Northwest-southeast cross-section extending from the remains of the Theodosian portico to the northern main pier of Hagia Sophia.

The floor level of the passage under the esonarthex aligns nearly with the remains of the Theodosian Hagia Sophia's portico (see Figs. 1, 5), suggesting a significant connection. This alignment indicates that when constructing the esonarthex and exonarthex of Justinian's Hagia Sophia, much of the Theodosian Hagia Sophia's atrium was incorporated. This passage serves as a defining space, marking a transitional phase between the two monuments from the fifth to the sixth centuries. Presenting the only visible façade of the foundation of the present structure standing on the previous one, the plastered wall of this subterranean structure also provides knowledge for the foundation substructure.

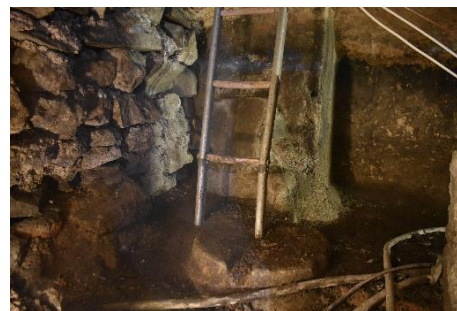
**Fig. 7.** The column base on the floor of the passage.

The plastered interior surfaces formerly initially suggest that the passage under the esonarthex might have functioned as a cistern [3] (see Fig. 6). However, its connections with channels at lower elevations on the northeastern and southwestern ends refute this function. Instead, this substantial space, believed to be the most voluminous among Hagia Sophia's subterranean structures, appears to have served as an air-ventilation conduit and a transition point to access water lines aligned on its northeast-southwest ends. Notably, there is a column base on the floor of this passage beneath the entry lid, that might have belonged to the Theodosian Hagia Sophia due to its location. While this possibly in situ column base holds promise for shedding light on the reconstruction of the Theodosian Hagia Sophia, no other column bases on the same axis were observed, impeding a definitive assessment. Positioned approximately 1.50 meters from the Imperial Gate, the main axis of the structure, it seems improbable that this base belongs to the interior colonnade of the Theodosian Hagia Sophia's naos (see Fig. 7). Considering a possible column base on the opposite side of the axis, allowing for a total span of only 3 meters, would be insufficient for the beam span of the previous naos. So, this finding suggests that it might have belonged to the arcade of the Theodosian atrium.

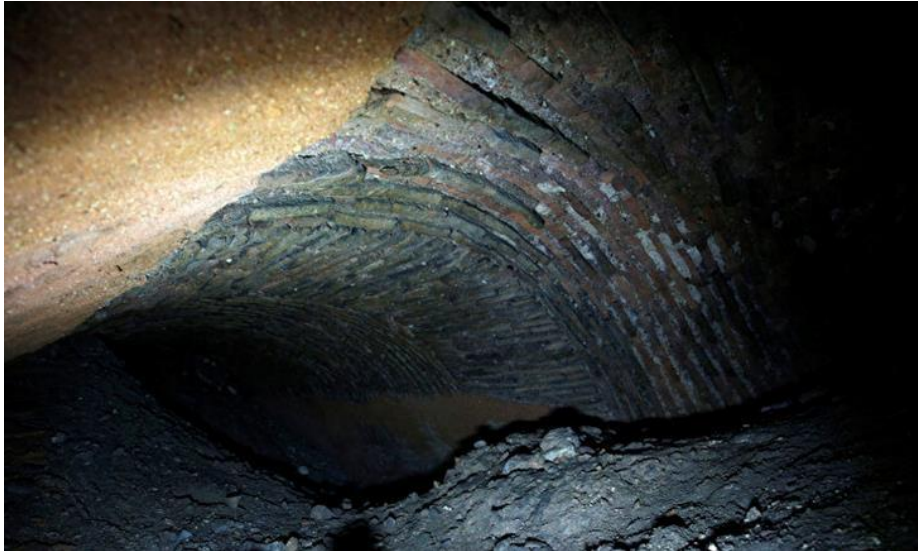
**Fig. 16.** View from the second vault under the north corner of the Justinian's atrium.

This vault is linked to another subterranean structure positioned above, with a channel extending northwestward from its western corner (see Fig. 16). This second vault, could be measured 5 meters in width and 11 meters in length with the debris inside. It is covered by a barrel vault and, akin to its counterpart, is filled with debris and soil that was deposited from the courtyard. However, the brickwork of this vault differs from the previous space and features bricks laid both vertically and horizontally. Partial plasters can also be observed on its vault and side walls. Despite Schneider's assumption regarding the continuation of the atrium's substructures beneath the rest wings [5], these presumed spaces were unable to access.

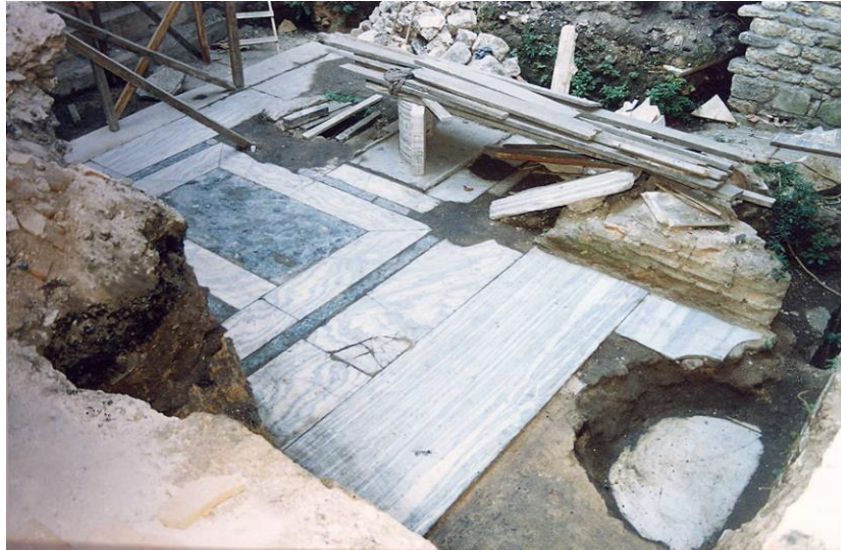
**Fig. 19.** Marble floor pavement above the hypogeum exposed after the excavation in 1985.

The hypogeum is a subterranean Roman tomb situated between Hagia Sophia and the Hagia Sophia Imaret (also known as the "soup kitchen"). Consisting of three chambers interconnected by a passage, this structure is dated back to the 4th century, predating the current Hagia Sophia. Following the conversion of Hagia Sophia into a museum in 1934, this hypogeum was first discovered and documented in 1946 by Muzaffer Ramazanoğlu, the museum director at that time [9]. Ramazanoğlu dated this subterranean complex, noting two distinct layers on the superstructure floor, to the 4th century. Although the hypogeum was republished in 1962 [10], it subsequently faded into obscurity. However, it was rediscovered, along with its pavement floor, during an excavation in 1985 aimed at locating the toilet drain of the guard room attached to the northeastern wall of Hagia Sophia. The guard room was likely constructed on the hypogeum in the first half of the 20th century. The excavation process then proceeded by removing the guard room, which was initially intended for repairs. As the excavation progressed, the original pavement of the hypogeum's superstructure was revealed (see Fig. 19). This pavement, composed of white Marmara marbles and Verde Antico marbles even not used together in Hagia Sophia's interior floor, was uncovered. Additionally, a smaller white marble surface, along with its marble baseboard from an earlier period, was found approximately 40 cm below the upper level [11,12]. In this context, the white marble pavement within the lower layer, dated to the 4th century along with the hypogeum, suggests it may have been contemporaneous with the initial Hagia Sophia structure. The pavement on the upper layer, positioned at the level of the lower edge of partially surviving buttresses that constructed from brick and stone, is dated to the 6th century together with the attached buttresses [13]. Following the documentation of the hypogeum's superstructure, the marble pavement was once again covered with soil in 1985 for preservation purposes [11,12].

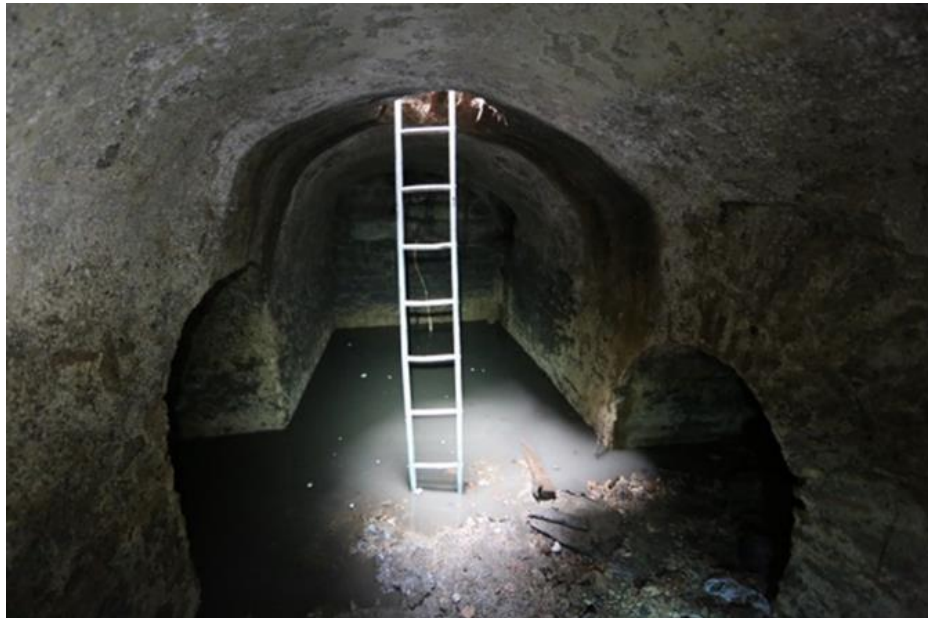
**Fig. 20.** View from the hypogeum in 2020 before the cleaning.

This structure complex spans approximately 60 square meters and lies approximately 4 meters below the current ground level. Comprising three rectangular-planned spaces, each boasting a long side of about 8 meters, this arrangement features various access points. A circular hole, concealed by an iron lid, permits entry to the central space of the hypogeum from the ground level. Additionally, a gradual transition gap allows access to the southeastern end of the space. These three spaces, aligned in a southeast-northwest direction, run parallel to each other and are linked by an arched passage in the middle (see Fig. 20). The chambers situated in the middle and southwest directions lie beneath the Vizier Garden, while the northeastern-oriented chamber is located under the courtyard of the Hagia Sophia Imaret. Notably, the chamber in the middle possesses a distinctive marble door jamb along its southeastern edge. Within the side chambers, niches known as "arcosolia" were traditionally used for housing the remains of the deceased. However, the arcosolia within this hypogeum currently remain vacant.
