Digital documentation of three largest subterranean structures of Hagia Sophia: The passage under the esonarthex, the vaults under the atrium and the hypogeum

Abstract. The terrestrial scanning project of Hagia Sophia's subterranean structures took place in 2020. This field study enabled the creation of a three-dimensional point cloud model capturing the underground tunnels and structures. Subsequently, in 2022, a more detailed documentation of the older hypogeum within Hagia Sophia was conducted. This study particularly focused on the three largest subterranean structures on the site. The first of these is the passage beneath the esonarthex, delineating a structural transition between the Theodosian and Justinian periods, spanning from the fifth to the sixth centuries. Notably, the discovery of a previously unnoticed column base on the floor of this structure prompted an update to the plan of the Theodosian atrium. The second focus lies on the vaults beneath Justinian's atrium, requiring an architectural visualization update since Schneider's documentation in 1941. These subterranean structures define the boundaries of the no longer physically existing Justinian atrium, and the d

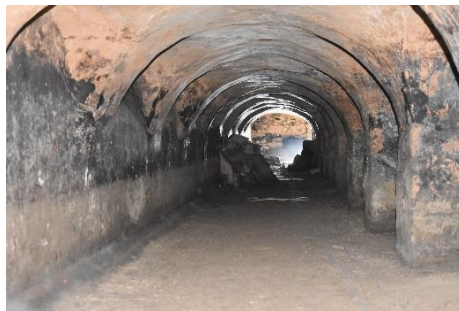
Fig. 6. The passage under the esonarthex

The plastered interior surfaces formerly initially suggest that the passage under the esonarthex might have functioned as a cistern [3] (see Fig. 6). However, its connections with channels at lower elevations on the northeastern and southwestern ends refute this function. Instead, this substantial space, believed to be the most voluminous among Hagia Sophia's subterranean structures, appears to have served as an air-ventilation conduit and a transition point to access water lines aligned on its northeast-southwest ends. Notably, there is a column base on the floor of this passage beneath the entry lid, that might have belonged to the Theodosian Hagia Sophia due to its location. While this possibly in situ column base holds promise for shedding light on the reconstruction of the Theodosian Hagia Sophia, no other column bases on the same axis were observed, impeding a definitive assessment. Positioned approximately 1.50 meters from the Imperial Gate, the main axis of the structure, it seems improbable that this base belongs to the interior colonnade of the Theodosian Hagia Sophia's naos (see Fig. 7). Considering a possible column base on the opposite side of the axis, allowing for a total span of only 3 meters, would be insufficient for the beam span of the previous naos. So, this finding suggests that it might have belonged to the arcade of the Theodosian atrium.

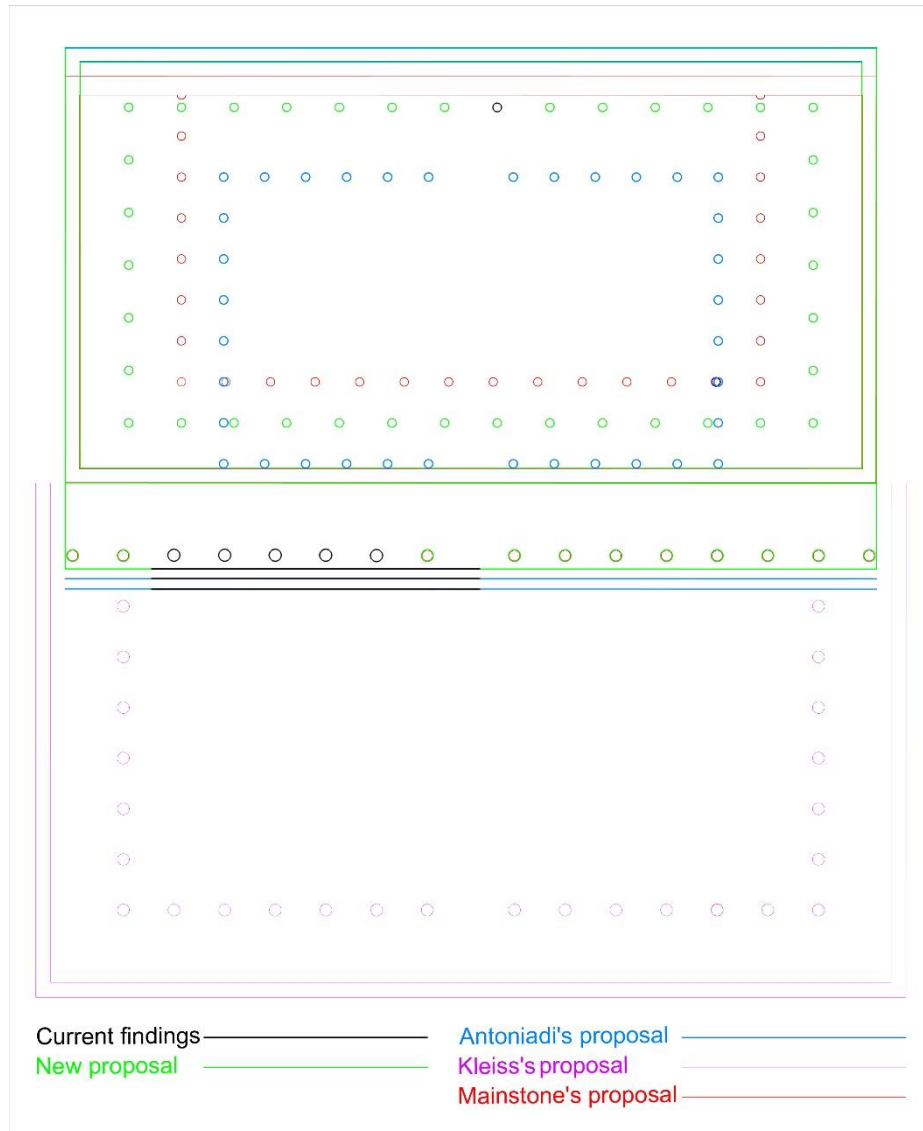
Fig. 13. Scaled comparison of the current proposal for the Theodosian atrium plan with the previous ones

The discovery of the column base within the passage under the esonarthex holds significant implications. This base stands as a pivotal piece of evidence, potentially serving as the sole and conclusive proof of the neglected southeastern wing of the Theodosian atrium, a detail that previously could not be observed by Mainstone. With a diameter of 57 cm compared to the approximately 80 cm diameters of the column bases at the portico, it suggests that the wings of the Theodosian atrium, now absent, were likely narrower than the entrance portico. This unexpected finding has sparked the development of a new proposal for the plan of the Theodosian atrium, possibly indicating the presence of four interior arcades (see Fig. 12). This fresh proposal could potentially enhance new speculative reconstructions of the Theodosian Hagia Sophia (see Fig. 13).

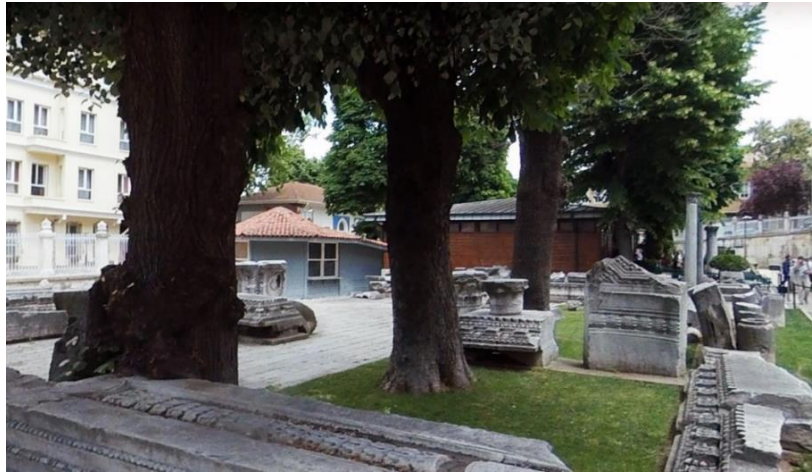
Fig. 15. The tree on the left shaped by the marble element, and the next one penetrating the vault.

Following the conversion of Hagia Sophia into a museum in 1934, Schneider was granted permission to excavate the remnants of Theodosian Hagia Sophia [8]. Notably, the marble elements from the Theodosian portico, unearthed during the excavation, displayed in the garden's northwestern section of Hagia Sophia. One of these stone elements, situated beside the chestnut tree, has compressed and shaped the lower trunk of it as the tree continued to grow. Meanwhile, another chestnut tree, which grew adjacent to the stone element, has also penetrated and damaged the vault of the first subterranean structure which will be defined below. Since Schneider did not document these trees, it can be inferred that they sprouted after his documentation of the subterranean structures within Justinian's atrium [5], essentially after the conversion of Hagia Sophia into a museum. Hence, these trees on the site are, at most, 90 years old (see Fig.15).

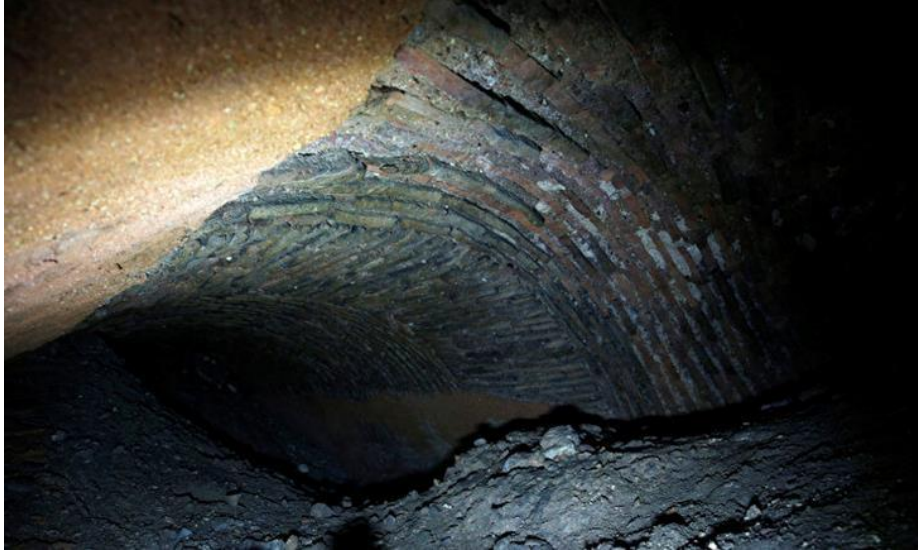
Fig. 16. View from the second vault under the north corner of the Justinian's atrium.

This vault is linked to another subterranean structure positioned above, with a channel extending northwestward from its western corner (see Fig. 16). This second vault, could be measured 5 meters in width and 11 meters in length with the debris inside. It is covered by a barrel vault and, akin to its counterpart, is filled with debris and soil that was deposited from the courtyard. However, the brickwork of this vault differs from the previous space and features bricks laid both vertically and horizontally. Partial plasters can also be observed on its vault and side walls. Despite Schneider's assumption regarding the continuation of the atrium's substructures beneath the rest wings [5], these presumed spaces were unable to access.

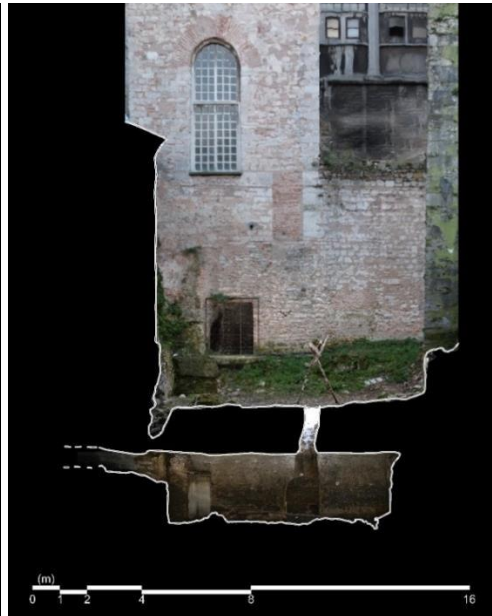
Fig. 23. Section 1-1 of the hypogeum.

The original ceiling height remains uncertain due to the accumulation of mud and debris on the floor. The buried appearance of the door jamb and the muddy floor surface suggest that the original ground level of the structure lies approximately 1 meter lower than the existing mud surface. At the end of 2021, a partial cleanup in the hypogeum removed 3875 kilograms of mud and debris, leaving the remainder (see Fig. 21). Subsequently, following the temporary removal of rainwater from inside the structure using a motor pump, a more favorable environment was created for documentation. As a result, the hypogeum was re-visualized in higher resolution in January 2022 [14] (see Figs. 22-25).

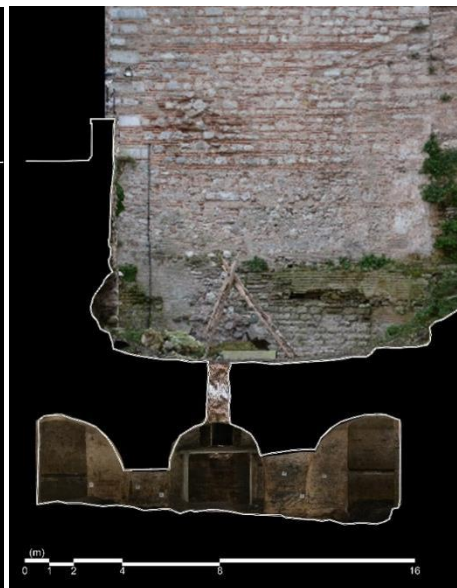
Fig. 25. Section 3-3 of the hypogeum.
