**Digital documentation of three largest subterranean structures of Hagia Sophia: The passage under the esonarthex, the vaults under the atrium and the hypogeum**

*Hasan Firat Diker*

**Abstract.** The terrestrial scanning project of Hagia Sophia's subterranean structures took place in 2020. This field study enabled the creation of a three-dimensional point cloud model capturing the underground tunnels and structures. Subsequently, in 2022, a more detailed documentation of the older hypogeum within Hagia Sophia was conducted. This study particularly focused on the three largest subterranean structures on the site. The first of these is the passage beneath the esonarthex, delineating a structural transition between the Theodosian and Justinian periods, spanning from the fifth to the sixth centuries. Notably, the discovery of a previously unnoticed column base on the floor of this structure prompted an update to the plan of the Theodosian atrium. The second focus lies on the vaults beneath Justinian's atrium, requiring an architectural visualization update since Schneider's documentation in 1941. These subterranean structures define the boundaries of the no longer physically existin

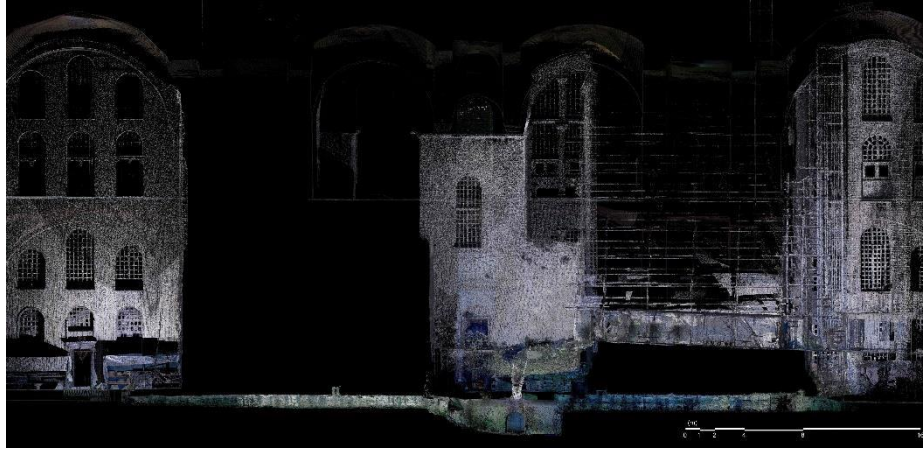
**Fig. 2.** Section 5-5: Southeast- northwest cross-section showing the middle chamber of the hypogeum and the channels running at its southeastern and northwestern ends.

However, the initial digital documentation of the hypogeum using the Leica BLK360 Camera Laser Scanner required an update due to low resolution, unnatural colors, and unclear structural edges (see Figs. 2-3). Furthermore, rainwater accumulation on the floor negatively affected this documentation. Subsequent to a partial cleanup that involved draining rainwater using a water pump, a more conducive working environment was established. This prompted a different approach for redocumentation opting for an image-based modeling technique rather than using the laser scanner. A 24-megapixel NIKON D5200 camera equipped with AF-S DX NIKKOR 18-105mm f/3.5-5.6G ED VR lens was employed to capture 958 internal and 596 external photographs at 300 dpi. Agisoft Metashape Professional program version 1.5.2 facilitated the creation of a three-dimensional imaging space, resulting in a more refined redocumentation of the hypogeum compared to the 2021 documentation. Despite debris obstructing visibility of the actual height and original floor, future visualization steps post-complete hypogeum cleaning will facilitate a comparative analysis of the structure's true height.

Two tunnels are connected to the hypogeum from the southeast and northeast. The southeastern tunnel originates from the rain gutter at ground level between Hagia Sophia and the Skeuophylakion, inclining until it terminates at the upper level of the southeastern edge of the middle chamber. Conversely, the other tunnel begins from the upper level of the northwestern corner of the same middle space and extends northwestward. These tunnels likely coincide in timing with Architect Sinan's buttresses, considering their locations (see Figs. 1-3).

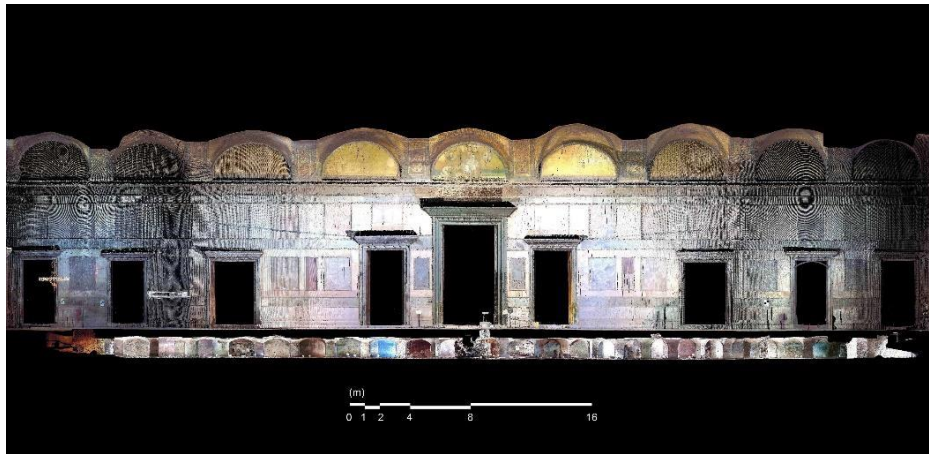
**Fig. 4.** Section 1-1: Northeast-southwest cross-section of the passage under the esonarthex.

Accessible through an opening west of the Imperial Gate (see Figs. 1, 4), the passage beneath the esonarthex resides approximately 2 meters below the ground floor. Measuring 4 meters in width and spanning 47.50 meters in length, this space runs along a northeastern-southwestern axis beneath the southeastern half of the esonarthex. Its ceiling consists of cross vaults connected in the middle with the 23 masonry piers aligned in row. Notably, three channels extend from each end of this passage, diverging in various directions. Serving as a central nexus, this passage interconnects with the subterranean tunnels extending both within and outside the Hagia Sophia structure. On the other hand, in comparison to the following two subterranean structures, this passage is in good condition structurally and free of debris.

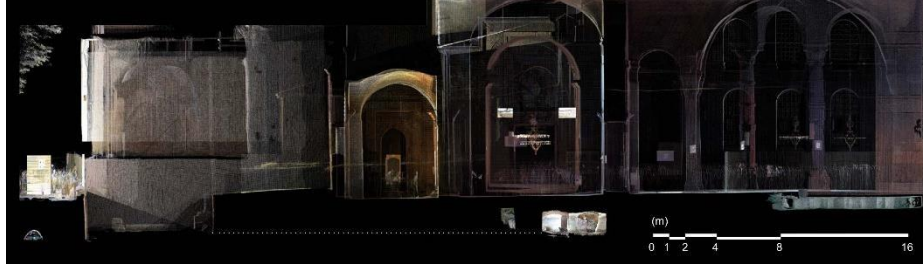
**Fig. 5.** Section 2-2: Northwest-southeast cross-section extending from the remains of the Theodosian portico to the northern main pier of Hagia Sophia.

The floor level of the passage under the esonarthex aligns nearly with the remains of the Theodosian Hagia Sophia's portico (see Figs. 1, 5), suggesting a significant connection. This alignment indicates that when constructing the esonarthex and exonarthex of Justinian's Hagia Sophia, much of the Theodosian Hagia Sophia's atrium was incorporated. This passage serves as a defining space, marking a transitional phase between the two monuments from the fifth to the sixth centuries. Presenting the only visible façade of the foundation of the present structure standing on the previous one, the plastered wall of this subterranean structure also provides knowledge for the foundation substructure.

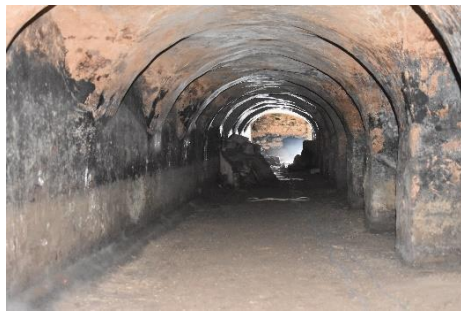
**Fig. 6.** The passage under the esonarthex

The plastered interior surfaces formerly initially suggest that the passage under the esonarthex might have functioned as a cistern [3] (see Fig. 6). However, its connections with channels at lower elevations on the northeastern and southwestern ends refute this function. Instead, this substantial space, believed to be the most voluminous among Hagia Sophia's subterranean structures, appears to have served as an air-ventilation conduit and a transition point to access water lines aligned on its northeast-southwest ends. Notably, there is a column base on the floor of this passage beneath the entry lid, that might have belonged to the Theodosian Hagia Sophia due to its location. While this possibly in situ column base holds promise for shedding light on the reconstruction of the Theodosian Hagia Sophia, no other column bases on the same axis were observed, impeding a definitive assessment. Positioned approximately 1.50 meters from the Imperial Gate, the main axis of the structure, it seems improbable that this base belongs to the interior colonnade of the Theodosian Hagia Sophia's naos (see Fig. 7). Considering a possible column base on the opposite side of the axis, allowing for a total span of only 3 meters, would be insufficient for the beam span of the previous naos. So, this finding suggests that it might have belonged to the arcade of the Theodosian atrium.

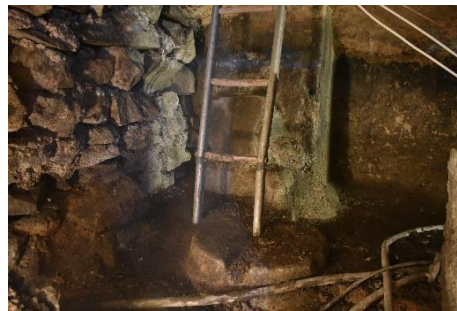
**Fig. 7.** The column base on the floor of the passage.

The discovery of the column base within the passage under the esonarthex holds significant implications. This base stands as a pivotal piece of evidence, potentially serving as the sole and conclusive proof of the neglected southeastern wing of the Theodosian atrium, a detail that previously could not be observed by Mainstone. With a diameter of 57 cm compared to the approximately 80 cm diameters of the column bases at the portico, it suggests that the wings of the Theodosian atrium, now absent, were likely narrower than the entrance portico. This unexpected finding has sparked the development of a new proposal for the plan of the Theodosian atrium, possibly indicating the presence of four interior arcades (see Fig. 12). This fresh proposal could potentially enhance new speculative reconstructions of the Theodosian Hagia Sophia (see Fig. 13).

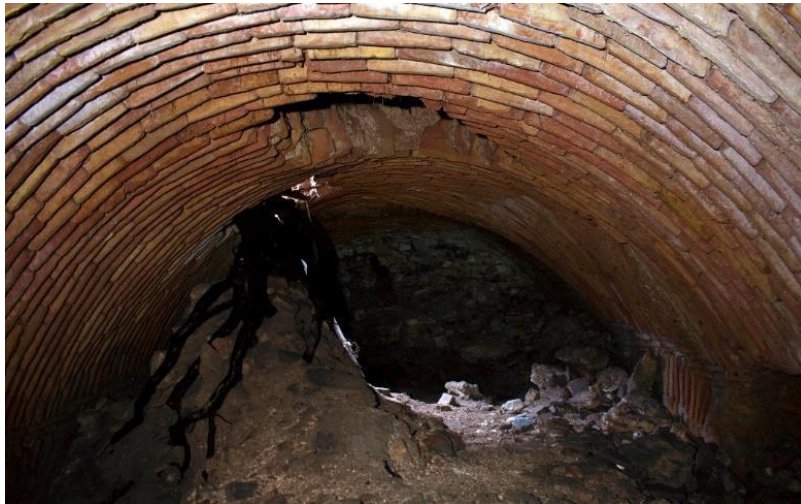
**Fig. 14.** View from the first vault under the northeastern wing of the Justinian's atrium.

To the northwest of Hagia Sophia, stand two impressive subterranean structures that have been digitally documented (see Fig. 1). The first structure, which boasts a rectangular plan and remains unplastered, is accessible from the southeastern edge of its barrel vault. Notably, a chestnut tree has breached its vault, causing structural damage over time (see Fig. 14). The second vault also follows a rectangular plan, and these

The initial vault penetrated by the tree roots measures 5 meters in width and spans a length of 17 meters. But it has gradually filled with debris and soil over time. Consequently, the ground surface and height within the space remain obscured due to this accumulation. Within the masonry of the vault, the bricks are corbelled along their longitudinal sides. The unplastered brickwork starts vertically from the northwest side and gradually inclines towards the southeast. There are also two waterway tunnels intersecting this structure in the northeast-southwest direction that were later blocked.

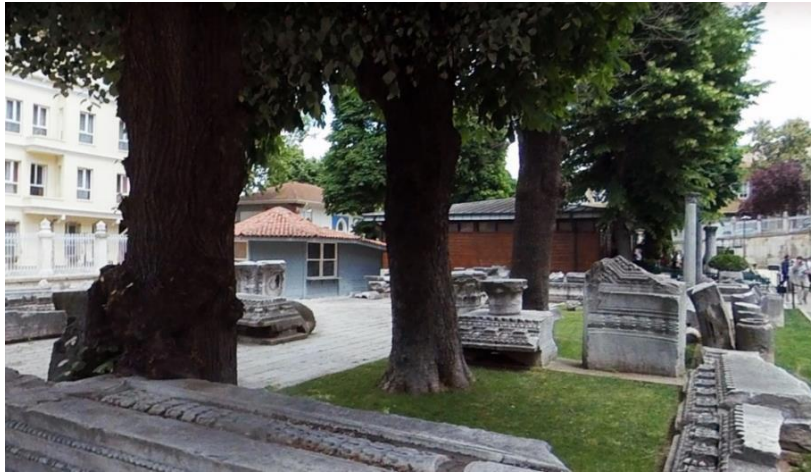
**Fig. 15.** The tree on the left shaped by the marble element, and the next one penetrating the vault.

Following the conversion of Hagia Sophia into a museum in 1934, Schneider was granted permission to excavate the remnants of Theodosian Hagia Sophia [8]. Notably, the marble elements from the Theodosian portico, unearthed during the excavation, displayed in the garden's northwestern section of Hagia Sophia. One of these stone elements, situated beside the chestnut tree, has compressed and shaped the lower trunk of it as the tree continued to grow. Meanwhile, another chestnut tree, which grew adjacent to the stone element, has also penetrated and damaged the vault of the first subterranean structure which will be defined below. Since Schneider did not document these trees, it can be inferred that they sprouted after his documentation of the subterranean structures within Justinian's atrium [5], essentially after the conversion of Hagia Sophia into a museum. Hence, these trees on the site are, at most, 90 years old (see Fig.15).

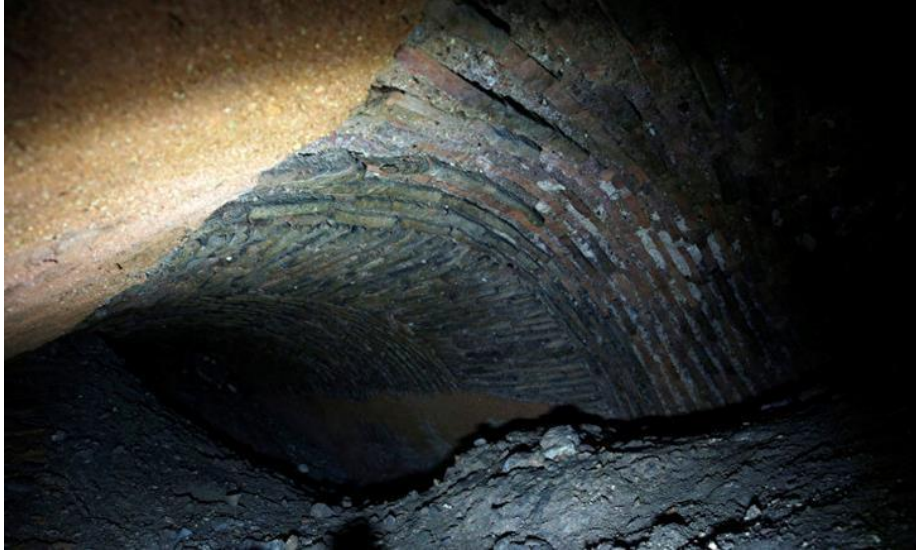
**Fig. 16.** View from the second vault under the north corner of the Justinian's atrium.

This vault is linked to another subterranean structure positioned above, with a channel extending northwestward from its western corner (see Fig. 16). This second vault, could be measured 5 meters in width and 11 meters in length with the debris inside. It is covered by a barrel vault and, akin to its counterpart, is filled with debris and soil that was deposited from the courtyard. However, the brickwork of this vault differs from the previous space and features bricks laid both vertically and horizontally. Partial plasters can also be observed on its vault and side walls. Despite Schneider's assumption regarding the continuation of the atrium's substructures beneath the rest wings [5], these presumed spaces were unable to access.

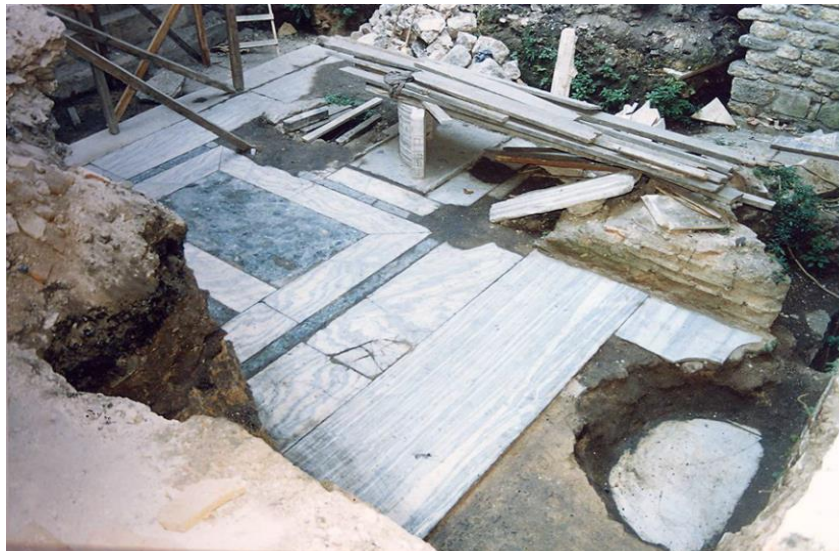
**Fig. 19.** Marble floor pavement above the hypogeum exposed after the excavation in 1985.

The hypogeum is a subterranean Roman tomb situated between Hagia Sophia and the Hagia Sophia Imaret (also known as the "soup kitchen"). Consisting of three chambers interconnected by a passage, this structure is dated back to the 4th century, predating the current Hagia Sophia. Following the conversion of Hagia Sophia into a museum in 1934, this hypogeum was first discovered and documented in 1946 by Muzaffer Ramazanoğlu, the museum director at that time [9]. Ramazanoğlu dated this subterranean complex, noting two distinct layers on the superstructure floor, to the 4th century. Although the hypogeum was republished in 1962 [10], it subsequently faded into obscurity. However, it was rediscovered, along with its pavement floor, during an excavation in 1985 aimed at locating the toilet drain of the guard room attached to the northeastern wall of Hagia Sophia. The guard room was likely constructed on the hypogeum in the first half of the 20th century. The excavation process then proceeded by removing the guard room, which was initially intended for repairs. As the excavation progressed, the original pavement of the hypogeum's superstructure was revealed (see Fig. 19). This pavement, composed of white Marmara marbles and Verde Antico marbles even not used together in Hagia Sophia's interior floor, was uncovered. Additionally, a smaller white marble surface, along with its marble baseboard from an earlier period, was found approximately 40 cm below the upper level [11,12]. In this context, the white marble pavement within the lower layer, dated to the 4th century along with the hypogeum, suggests it may have been contemporaneous with the initial Hagia Sophia structure. The pavement on the upper layer, positioned at the level of the lower edge of partially surviving buttresses that constructed from brick and stone, is dated to the 6th century together with the attached buttresses [13]. Following the documentation of the hypogeum's superstructure, the marble pavement was once again covered with soil in 1985 for preservation purposes [11,12].

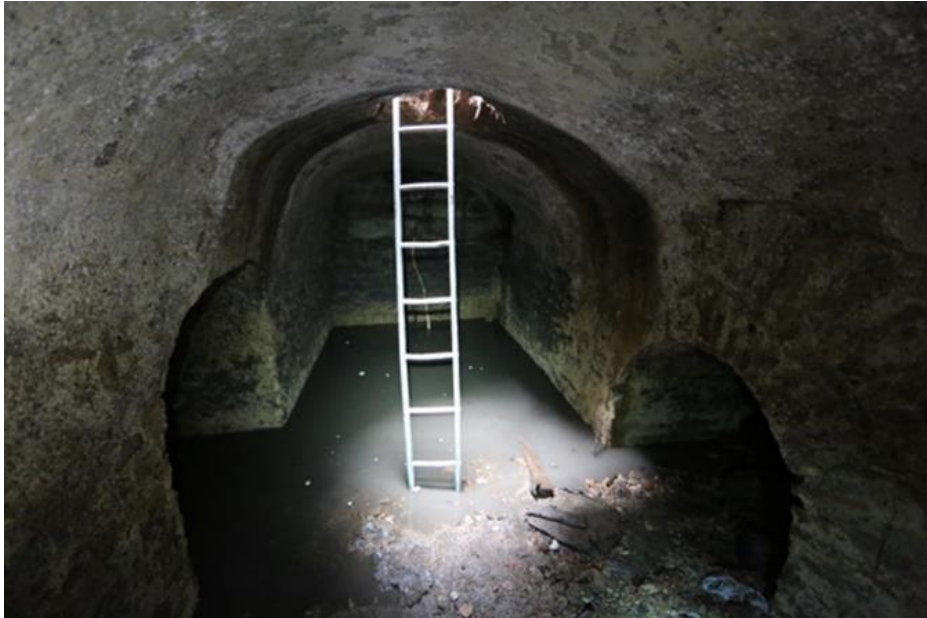
**Fig. 20.** View from the hypogeum in 2020 before the cleaning.

This structure complex spans approximately 60 square meters and lies approximately 4 meters below the current ground level. Comprising three rectangular-planned spaces, each boasting a long side of about 8 meters, this arrangement features various access points. A circular hole, concealed by an iron lid, permits entry to the central space of the hypogeum from the ground level. Additionally, a gradual transition gap allows access to the southeastern end of the space. These three spaces, aligned in a southeast-northwest direction, run parallel to each other and are linked by an arched passage in the middle (see Fig. 20). The chambers situated in the middle and southwest directions lie beneath the Vizier Garden, while the northeastern-oriented chamber is located under the courtyard of the Hagia Sophia Imaret. Notably, the chamber in the middle possesses a distinctive marble door jamb along its southeastern edge. Within the side chambers, niches known as "arcosolia" were traditionally used for housing the remains of the deceased. However, the arcosolia within this hypogeum currently remain vacant.

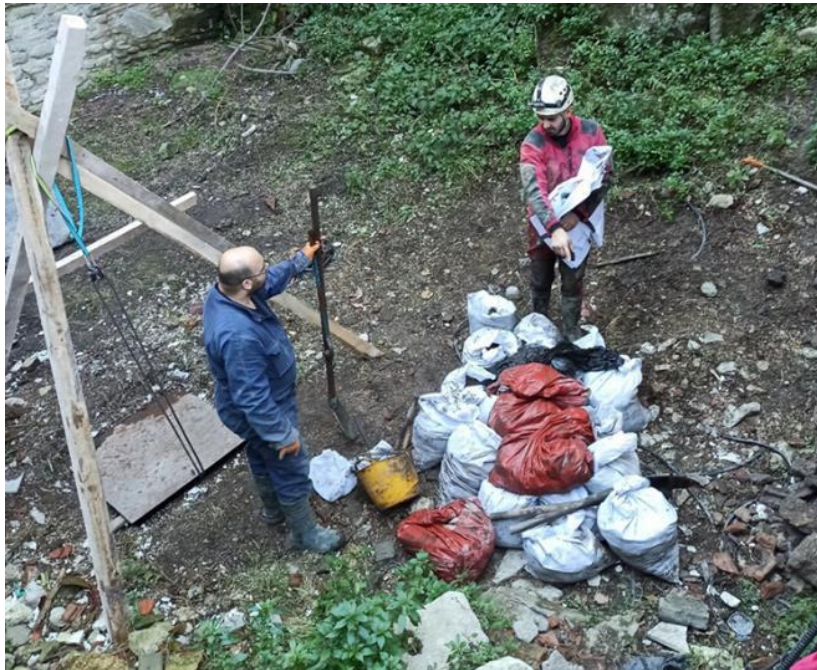
**Fig. 21.** View from the debris and mud removed from the hypogeum in 2021.

The original ceiling height remains uncertain due to the accumulation of mud and debris on the floor. The buried appearance of the door jamb and the muddy floor surface suggest that the original ground level of the structure lies approximately 1 meter lower than the existing mud surface. At the end of 2021, a partial cleanup in the hypogeum removed 3875 kilograms of mud and debris, leaving the remainder (see Fig. 21). Subsequently, following the temporary removal of rainwater from inside the structure using a motor pump, a more favorable environment was created for documentation. As a result, the hypogeum was re-visualized in higher resolution in January 2022 [14] (see Figs. 22-25).

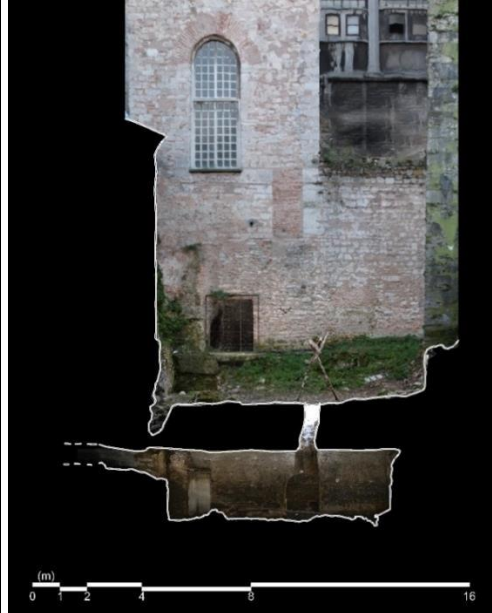
**Fig. 23.** Section 1-1 of the hypogeum.

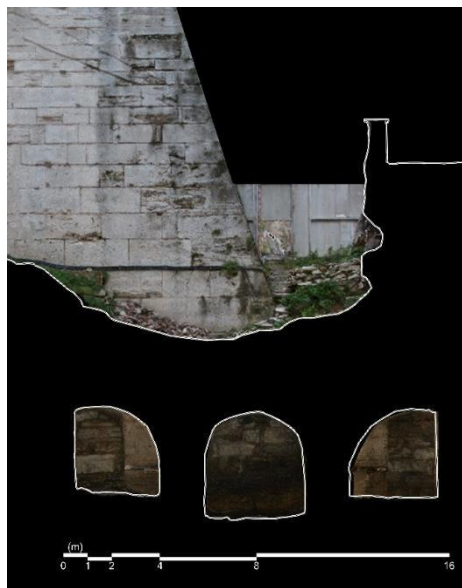
**Fig. 24.** Section 2-2 of the hypogeum

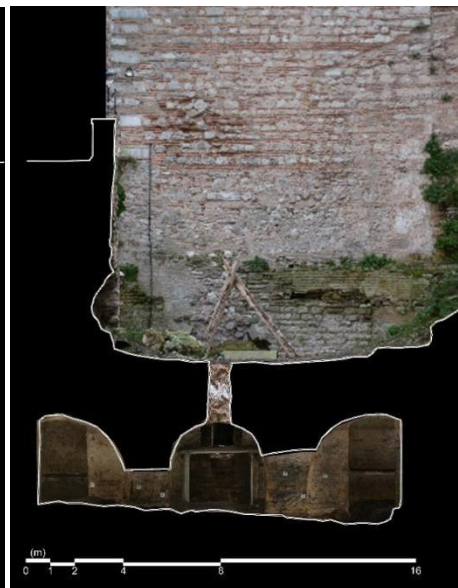
**Fig. 25.** Section 3-3 of the hypogeum.
