Vol 1, No 3 (2023)

**Digital documentation of three largest subterranean structures of Hagia Sophia: The passage under the esonarthex, the vaults under the atrium and the hypogeum**

*Hasan Firat Diker*

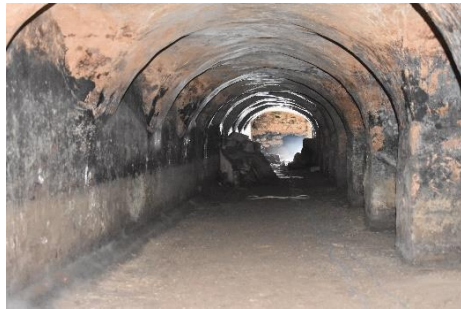
**Fig. 6.** The passage under the esonarthex

The plastered interior surfaces formerly initially suggest that the passage under the esonarthex might have functioned as a cistern [3] (see Fig. 6). However, its connections with channels at lower elevations on the northeastern and southwestern ends refute this function. Instead, this substantial space, believed to be the most voluminous among Hagia Sophia's subterranean structures, appears to have served as an air-ventilation conduit and a transition point to access water lines aligned on its northeast-southwest ends. Notably, there is a column base on the floor of this passage beneath the entry lid, that might have belonged to the Theodosian Hagia Sophia due to its location. While this possibly in situ column base holds promise for shedding light on the reconstruction of the Theodosian Hagia Sophia, no other column bases on the same axis were observed, impeding a definitive assessment. Positioned approximately 1.50 meters from the Imperial Gate, the main axis of the structure, it seems improbable that this base belongs to the interior colonnade of the Theodosian Hagia Sophia's naos (see Fig. 7). Considering a possible column base on the opposite side of the axis, allowing for a total span of only 3 meters, would be insufficient for the beam span of the previous naos. So, this finding suggests that it might have belonged to the arcade of the Theodosian atrium.

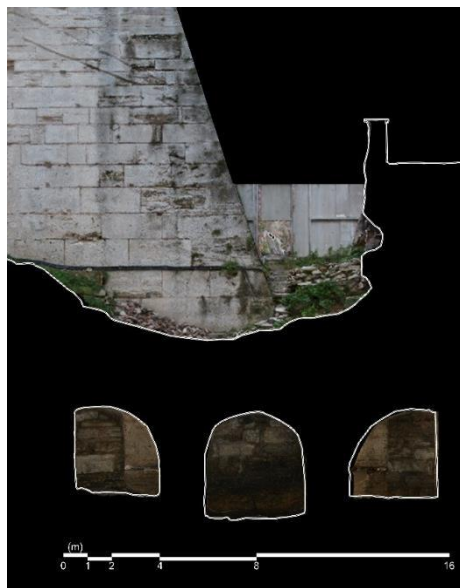
**Fig. 24.** Section 2-2 of the hypogeum

The original ceiling height remains uncertain due to the accumulation of mud and debris on the floor. The buried appearance of the door jamb and the muddy floor surface suggest that the original ground level of the structure lies approximately 1 meter lower than the existing mud surface. At the end of 2021, a partial cleanup in the hypogeum removed 3875 kilograms of mud and debris, leaving the remainder (see Fig. 21). Subsequently, following the temporary removal of rainwater from inside the structure using a motor pump, a more favorable environment was created for documentation. As a result, the hypogeum was re-visualized in higher resolution in January 2022 [14] (see Figs. 22-25).
