Digital documentation of three largest subterranean structures of Hagia Sophia: The passage under the esonarthex, the vaults under the atrium and the hypogeum

Abstract. The terrestrial scanning project of Hagia Sophia's subterranean structures took place in 2020. This field study enabled the creation of a three-dimensional point cloud model capturing the underground tunnels and structures. Subsequently, in 2022, a more detailed documentation of the older hypogeum within Hagia Sophia was conducted. This study particularly focused on the three largest subterranean structures on the site. The first of these is the passage beneath the esonarthex, delineating a structural transition between the Theodosian and Justinian periods, spanning from the fifth to the sixth centuries. Notably, the discovery of a previously unnoticed column base on the floor of this structure prompted an update to the plan of the Theodosian atrium. The second focus lies on the vaults beneath Justinian's atrium, requiring an architectural visualization update since Schneider's documentation in 1941. These subterranean structures define the boundaries of the no longer physically existing Justinian atrium, and the d

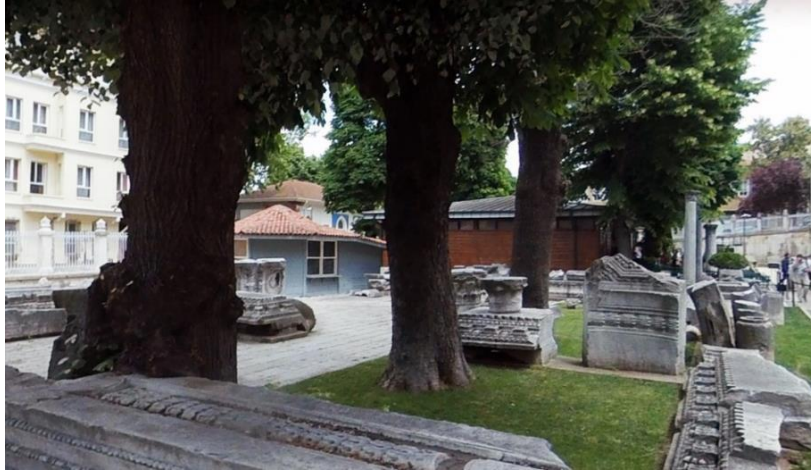
Fig. 15. The tree on the left shaped by the marble element, and the next one penetrating the vault.

Following the conversion of Hagia Sophia into a museum in 1934, Schneider was granted permission to excavate the remnants of Theodosian Hagia Sophia [8]. Notably, the marble elements from the Theodosian portico, unearthed during the excavation, displayed in the garden's northwestern section of Hagia Sophia. One of these stone elements, situated beside the chestnut tree, has compressed and shaped the lower trunk of it as the tree continued to grow. Meanwhile, another chestnut tree, which grew adjacent to the stone element, has also penetrated and damaged the vault of the first subterranean structure which will be defined below. Since Schneider did not document these trees, it can be inferred that they sprouted after his documentation of the subterranean structures within Justinian's atrium [5], essentially after the conversion of Hagia Sophia into a museum. Hence, these trees on the site are, at most, 90 years old (see Fig.15).

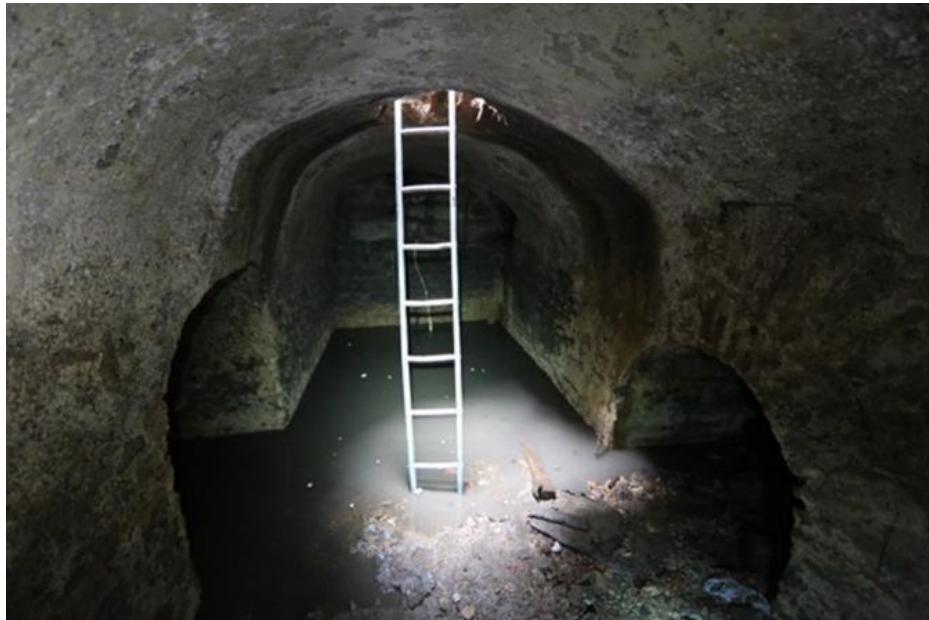
Fig. 20. View from the hypogeum in 2020 before the cleaning.

This structure complex spans approximately 60 square meters and lies approximately 4 meters below the current ground level. Comprising three rectangular-planned spaces, each boasting a long side of about 8 meters, this arrangement features various access points. A circular hole, concealed by an iron lid, permits entry to the central space of the hypogeum from the ground level. Additionally, a gradual transition gap allows access to the southeastern end of the space. These three spaces, aligned in a southeast-northwest direction, run parallel to each other and are linked by an arched passage in the middle (see Fig. 20). The chambers situated in the middle and southwest directions lie beneath the Vizier Garden, while the northeastern-oriented chamber is located under the courtyard of the Hagia Sophia Imaret. Notably, the chamber in the middle possesses a distinctive marble door jamb along its southeastern edge. Within the side chambers, niches known as "arcosolia" were traditionally used for housing the remains of the deceased. However, the arcosolia within this hypogeum currently remain vacant.
