Digital documentation of three largest subterranean structures of Hagia Sophia: The passage under the esonarthex, the vaults under the atrium and the hypogeum

Abstract. The terrestrial scanning project of Hagia Sophia's subterranean structures took place in 2020. This field study enabled the creation of a three-dimensional point cloud model capturing the underground tunnels and structures. Subsequently, in 2022, a more detailed documentation of the older hypogeum within Hagia Sophia was conducted. This study particularly focused on the three largest subterranean structures on the site. The first of these is the passage beneath the esonarthex, delineating a structural transition between the Theodosian and Justinian periods, spanning from the fifth to the sixth centuries. Notably, the discovery of a previously unnoticed column base on the floor of this structure prompted an update to the plan of the Theodosian atrium. The second focus lies on the vaults beneath Justinian's atrium, requiring an architectural visualization update since Schneider's documentation in 1941. These subterranean structures define the boundaries of the no longer physically existing Justinian atrium, and the d

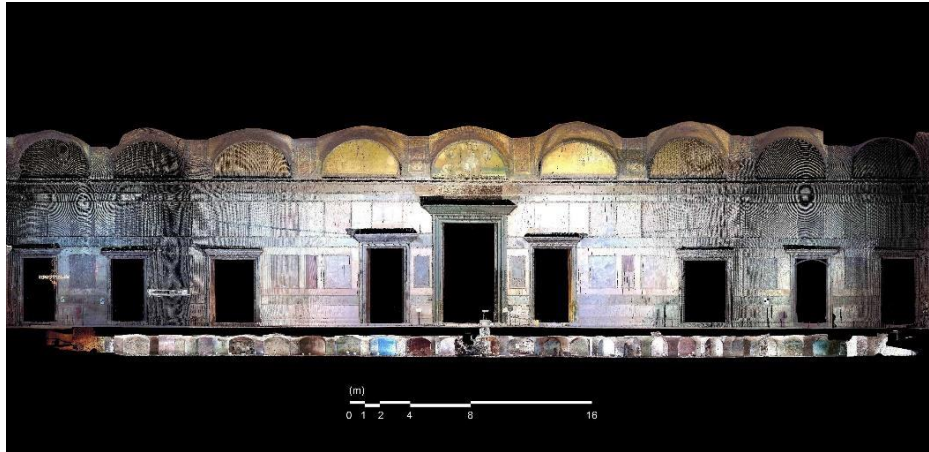
Fig. 4. Section 1-1: Northeast-southwest cross-section of the passage under the esonarthex.

Accessible through an opening west of the Imperial Gate (see Figs. 1, 4), the passage beneath the esonarthex resides approximately 2 meters below the ground floor. Measuring 4 meters in width and spanning 47.50 meters in length, this space runs along a northeastern-southwestern axis beneath the southeastern half of the esonarthex. Its ceiling consists of cross vaults connected in the middle with the 23 masonry piers aligned in row. Notably, three channels extend from each end of this passage, diverging in various directions. Serving as a central nexus, this passage interconnects with the subterranean tunnels extending both within and outside the Hagia Sophia structure. On the other hand, in comparison to the following two subterranean structures, this passage is in good condition structurally and free of debris.

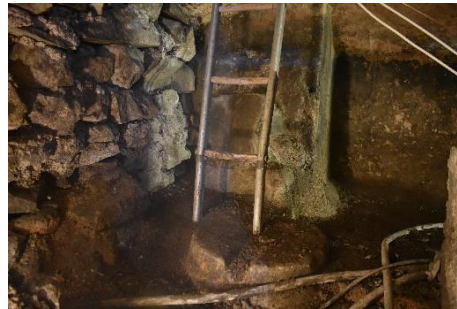
Fig. 7. The column base on the floor of the passage.

The discovery of the column base within the passage under the esonarthex holds significant implications. This base stands as a pivotal piece of evidence, potentially serving as the sole and conclusive proof of the neglected southeastern wing of the Theodosian atrium, a detail that previously could not be observed by Mainstone. With a diameter of 57 cm compared to the approximately 80 cm diameters of the column bases at the portico, it suggests that the wings of the Theodosian atrium, now absent, were likely narrower than the entrance portico. This unexpected finding has sparked the development of a new proposal for the plan of the Theodosian atrium, possibly indicating the presence of four interior arcades (see Fig. 12). This fresh proposal could potentially enhance new speculative reconstructions of the Theodosian Hagia Sophia (see Fig. 13).
